## Exploratory survey on the maintenance of Osun-Osogbo sacred grove, Nigeria.

### Abstract

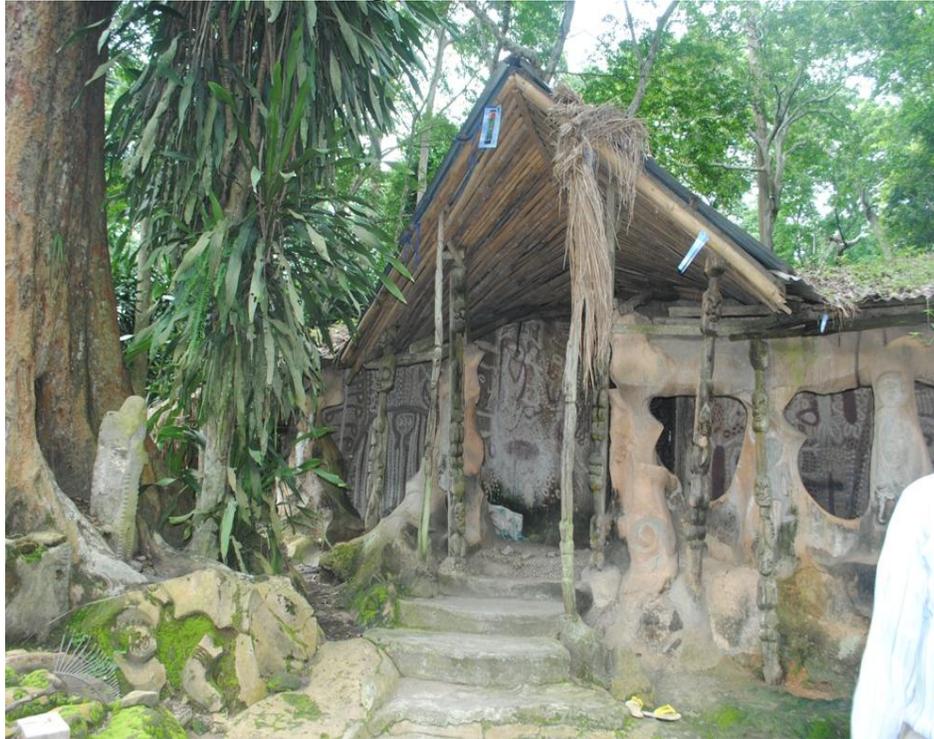
Plate 4: First Palace

According to Susanne Wenger, the outer shine walls of the Osun Temple and central altar were almost intact in the 1960s when the Osun Priestess then appealed to Susanne Wenger and other devotee Artists to salvage it

from termites that had started a subterranean invasion of the walls, pillars and roofs. It was in the process of doing this that art was created on the walls of the temple (which represents today the first palace) by the NewSacred Art movement artists (NCMM,2010).

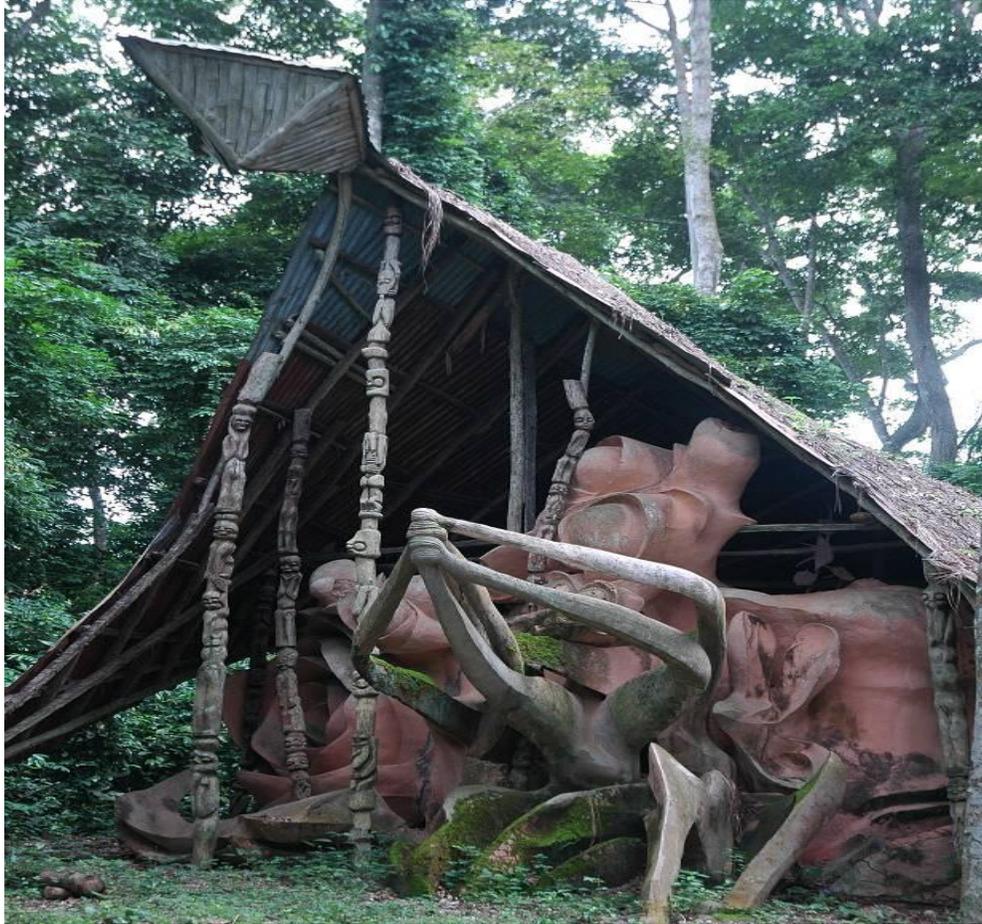
Plate 5: Second palace

The sacred palace (Iledi Ohuntoto) was the second residence of Larooye. It is about 600 meters from the first palace. It was built to avoid the effect of constant flooding experience at the first palace. Today the Ogboni Cult House stands within a symbolic reconstruction of the second palace. The Ogboni Cult is an elitist society of men of influence and affluence, similar to European

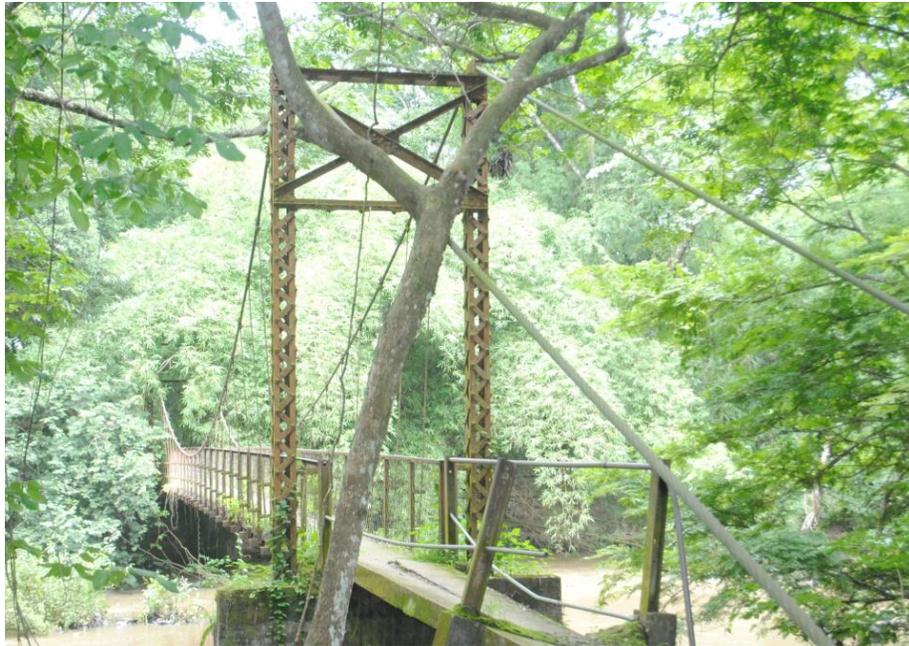
Plate 10: Suspension bridge

This is a colonial bridge built over the Osun river within the heart of the grove in 1935/36. It probably served as a temporary bridge to link Osogbo with other southern Yoruba towns, to carry supplies and men during the World War II. It now serves as a tourist trail and a viewing point of the Osun River as well as the surrounding grove.
